Geotechnical Technical Note June 2022

Project Name: Land at Worcester Lane, Stourbridge
Project No: 220903
Revision: P01
Reference: WLS-BWB-ZZ-XX-RP-CE-0001_GTN
Prepared by: N Gorst
Reviewed by: H Rehman

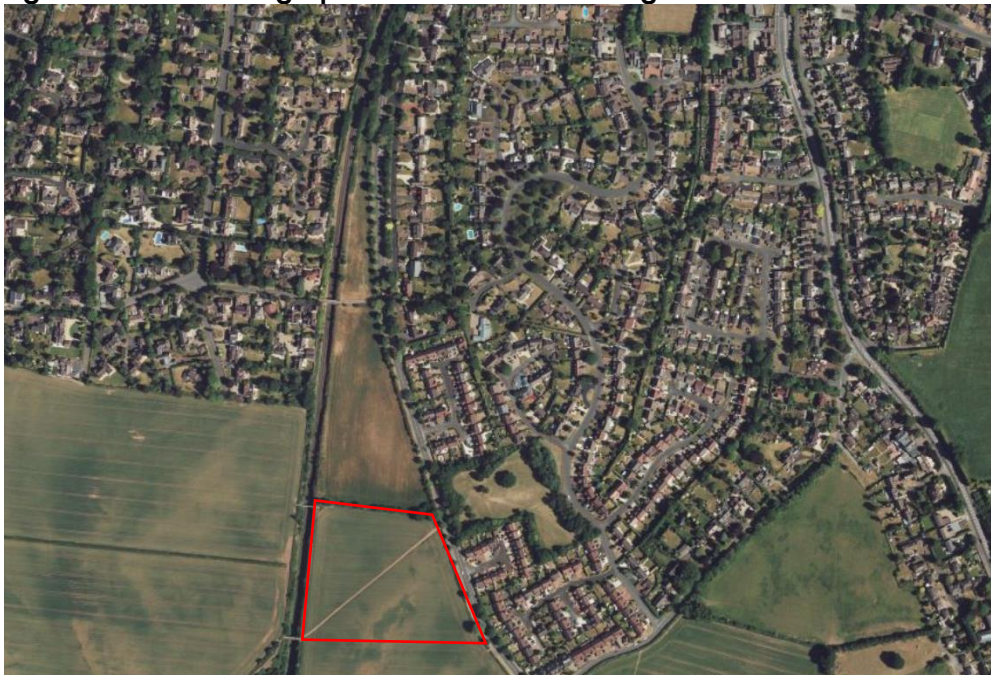
Figure 2: Aerial Photograph of Site and Surrounding Area

An aerial photograph (see **Figure 2**) confirms the presence of the pipeline and footpath. It is also readily discernible that further to the north of the subject site residential development has occurred adjacent to the railway line.

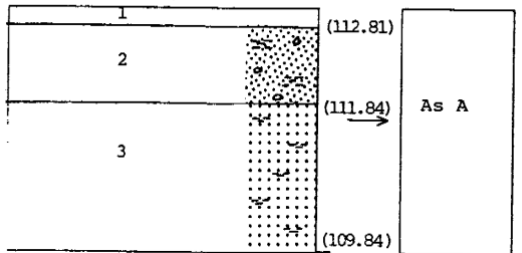
ELEVATIONS:— (Reduced level)
 (Not to scale)

Trial Pit No.
1/105

Co-ords
 E 390695.5
 N 281395.0

Ground Level 113.04 m.A.O.D.
 Date 2/12/89

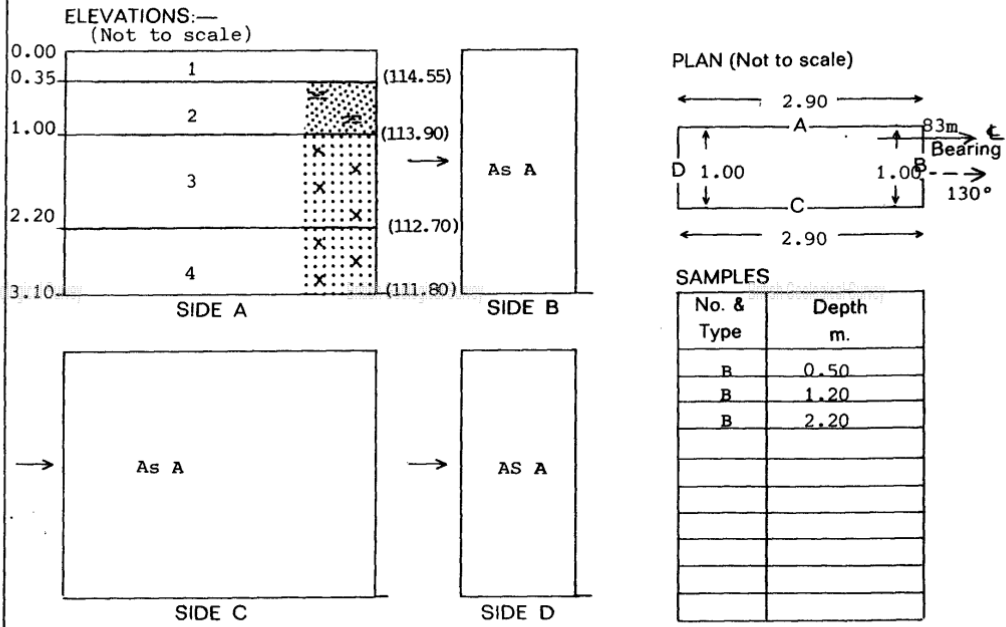
Trial Pit No.
1/106

Contract No. F8656
TRIAL PIT LOG
 Location WOR. GI. Contract No. 1 KBH Bypass
 Client Dept. of Transport
 Excavation Plant CAT 428
 Dimensions (l x b x h) 2.90 x 1.00 x 3.10m

Co-ords
 E 39073 9.0
 N 281348 5
 Ground Level 114.90 m.A.O.D.
 Date 2/12/89
